# Brookfield Home Inspections

## Home Inspection Report

999 Any Street, AnyTown NJ 07000

Prepared For: John Sample  
Inspection Date: 1/1/2024

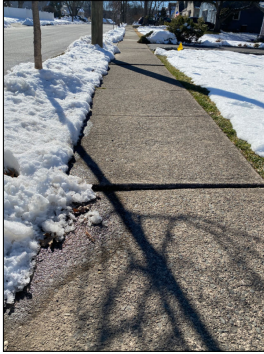
- The sidewalk has potential tripping hazard(s). This is where an abrupt change of 1" or more in the height of the surface is seen, or local deterioration and discontinuities are present. Recommend repair by a qualified professional.
- It was noted the surface of the driveway has areas that are settled and areas of generalized cracks . Recommend to have these areas repaired by a qualified professional to prevent further deterioration.

Trip Hazard

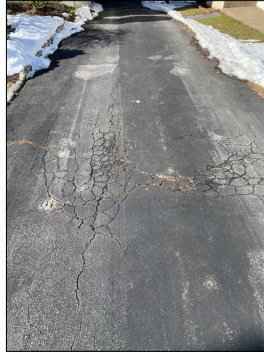
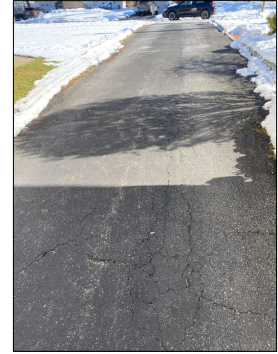
Local deterioration

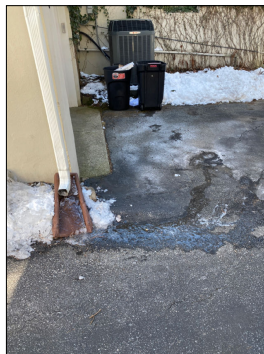
- One or more downspouts/leaders drained too close to the foundation. Excessively high moisture levels in soil supporting the foundation can effect its ability to support the weight of the structure above and can introduce water into the basement. Runoff water diverters should slope away from the home a minimum of ¼-inch per foot for a distance of at least six feet from the foundation. The Inspector recommends that these be corrected to improve drainage near the foundation.

Discharge too close to foundation

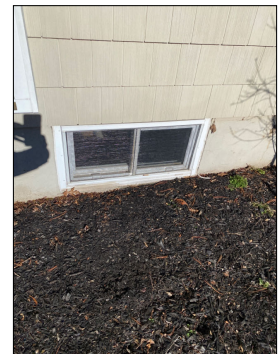
- The top of the foundation wall had inadequate clearance from grade. The top of the foundation wall should ideally be a minimum of six inches above soil. Inadequate clearance may result in moisture intrusion of the structure. Excessively high moisture levels can result in damage to the home structure or materials from decay or deterioration and may result in conditions which encourages rot and the growth of microbes such as mold fungi. The Inspector recommends re-grading around the home perimeter to provide increased clearance from grade.

Poor foundation clearance

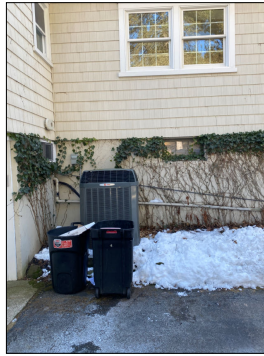
- Vines growing on the exterior walls may introduce insects, pests and/or accelerate deterioration of the exterior wall covering by retaining moisture. Over time, vine tendrils may damage wall covering materials. Watering this vegetation will introduce moisture to the soil which may eventually reach the foundation. Moisture in soil supporting the foundation can affect the ability of the foundation to support the weight of the structure above and can cause damage from soil heaving or settling, depending on soil composition and other conditions. The Inspector recommends removal of the vegetation from exterior walls.

Vegetation on walls

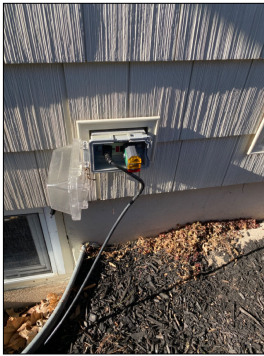
Incorrectly wired

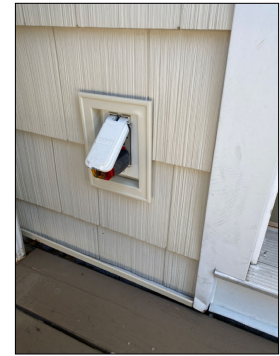
Incorrectly wired

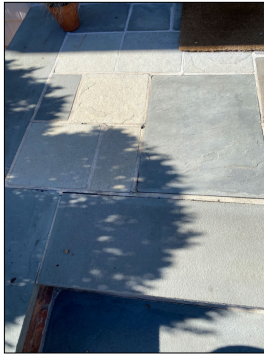
- Localized cracks/deterioration are noted at the front landing. These should be repaired by a qualified professional using appropriate material to avoid continued damage from freezing moisture.
- The door and/or it's seal is damaged at the rear deck door. This may have been caused by a dog. It

Cracking

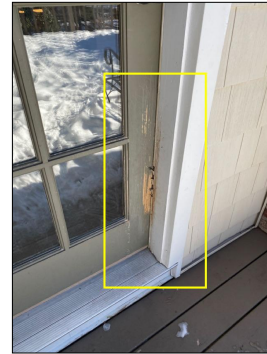
appears to be functional at the time of the inspection. This should be repaired to prevent further damage and the loss of weatherproofing. Recommend engaging a qualified professional for repair as needed.

Damage

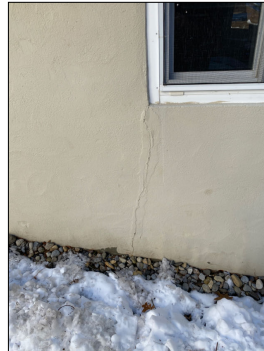
- Vinyl siding/shingles is/are the predominant type.
- Vertical cracks observed at foundation. No deflection of wall was visible at time of inspection. All buildings settle with minor wall and foundation cracking visible likely at some point. Recommend monitoring cracks for any changes, and having a qualified professional evaluate further should the cracks enlarge beyond their current size.

Cracking

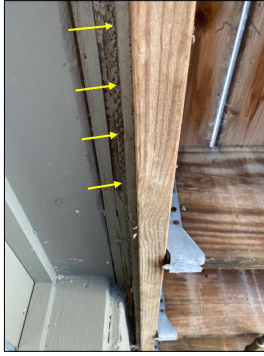
Page 11 Item: 7	Deck	<ul style="list-style-type: none"> <li>The deck was attached to the home by a ledger fastened to the exterior walls. The method for attaching the deck to the home did not appear to be consistent with standard building practice as the exterior siding was left in place at the ledger. This means that the nail/screw penetration into the home structure is reduced and may not provide adequate holding strength. This applies to the LHS and the side portion. The rest of the deck is supported on piers. The Inspector recommends that before the expiration of your Inspection Objection Deadline you may wish to consult with a qualified contractor to gain an idea of options and costs for any required correction.</li> </ul>
Page 12 Item: 8	Deck Stairs and rail	<ul style="list-style-type: none"> <li>Connections between the stair stringers (structural members which support the treads) and the treads/risers appeared to be inadequate at one or more points at this staircase. The Inspector recommends that you consult with a qualified professional before the end of your due diligence period for repair options and costs.</li> </ul>

- The deck **ledger board** was attached to the home with nails only. This may have been standard practice when the deck was built, but modern practice for attachment of the deck to the home structure is with ½-inch lag screws. While no failure was seen at the time of the inspection, the Inspector recommends having the installation reviewed by a qualified professional and repaired as necessary.

- **The deck was attached to the home by a ledger fastened to the exterior walls. The method for attaching the deck to the home did not appear to be consistent with standard building practice as the exterior siding was left in place at the ledger. This means that the nail/screw penetration into the home structure is reduced and may not provide adequate holding strength. This applies to the LHS and the side portion. The rest of the deck is supported on piers. The Inspector recommends that before the expiration of your Inspection Objection Deadline you may wish to consult with a qualified contractor to gain an idea of options and costs for any required correction.**

Ledger board over siding

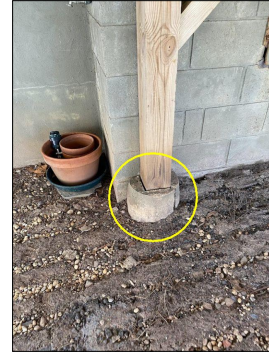
- The piers were embedded in the concrete footings which had all cracked. This will trap moisture against the timber leading to rot. Probing did not reveal any rot at the time of the inspection..All pads/footings should be repaired by a qualified professional.

Cracked footing

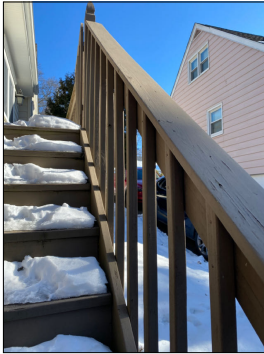
- The handrail did not comply with generally-accepted current safety standards mandating a "graspable" handrail. Consider having the handrail altered or replaced to make it compliant with modern safety standards.
- Deck guardrail assembly was loose at the RHS, posing a potential safety hazard, and should be made secure by a qualified contractor.
- **Connections between the stair stringers (structural members which support the treads) and the treads/risers appeared to be inadequate at one or more points at this staircase. The Inspector recommends that you consult with a qualified professional before the end of your due diligence period for repair options and costs.**

Non graspable handrail

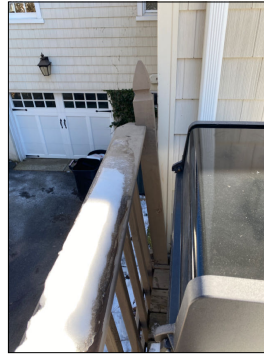
Loose

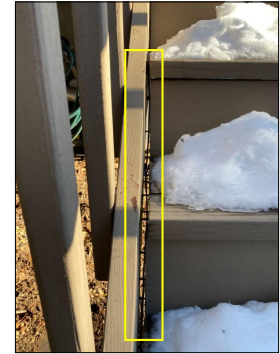
Failing stairs

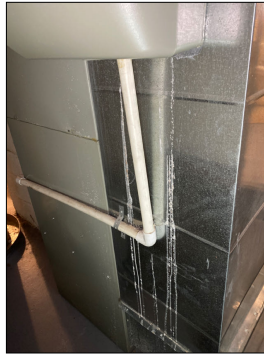
Humidifier leakage

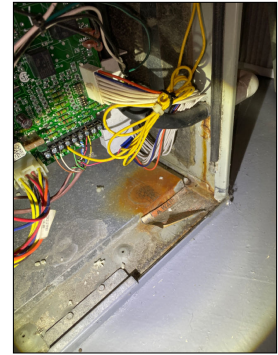
- The furnace/blower had visible corrosion that may be caused by improper handling of condensation. The Inspector recommends service by a qualified heating, ventilation and air-conditioning (HVAC) contractor.

Localized corrosion

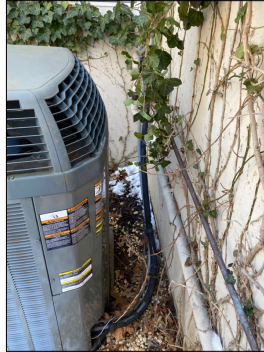
Vegetation

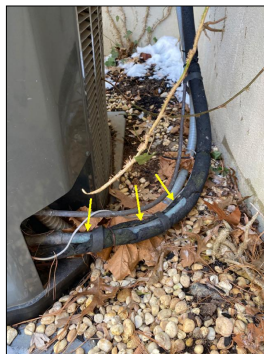
- The insulation is missing or damaged at exterior refrigerant line. Recommend repair/replacement by a qualified professional, perhaps as part of an annual maintenance contract.

Damaged/missing insulation

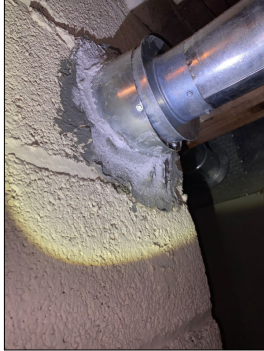
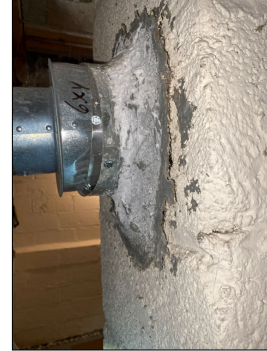
- The exhaust vent joint at the chimney shows signs of deterioration. This is a potentially hazardous condition if left unattended and that may allow toxic products of combustion (such as carbon monoxide) to enter the living space. The Inspector recommends repair by a qualified professional as part of your first annual boiler maintenance.

Junction deterioration

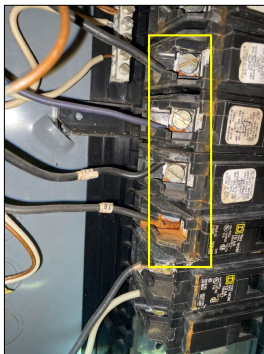
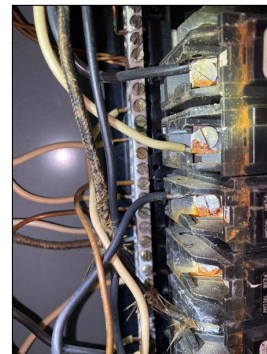
Page 16 Item: 2	Breakers	<ul style="list-style-type: none"> <li>One or more breaker exhibited corrosion. These breaker(s) may represent a safety issue and should be evaluated for safety and replaced as necessary by a qualified electrical contractor.</li> </ul>
-----------------	----------	---

- One or more breakers in the service panel were not wired to a circuit.
- **One or more breaker exhibited corrosion. These breaker(s) may represent a safety issue and should be evaluated for safety and replaced as necessary by a qualified electrical contractor.**

Corrosion

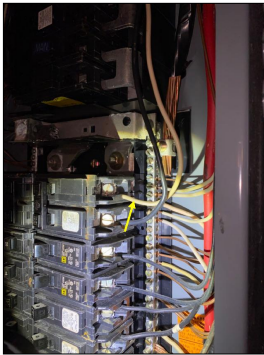
Unmarked 'hot' wiring

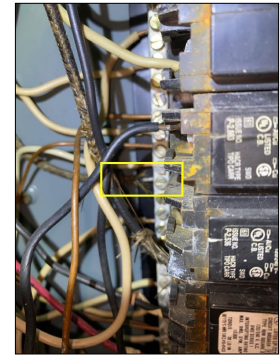
Page 17 Item: 3	Wiring	<ul style="list-style-type: none"> <li>Branch wiring visible inside the service panel MAY contain solid aluminum wiring which was commonly used in the 60's and 70's. Aluminum wiring correctly installed and maintained is acceptable, however, neglected aluminum wiring connections are a potential fire hazard. The Inspector recommends that you have the entire electrical system evaluated- and any necessary maintenance or corrections performed - by a qualified electrical contractor.</li> </ul>
-----------------	--------	--

- **Branch wiring visible inside the service panel MAY contain solid aluminum wiring which was commonly used in the 60's and 70's. Aluminum wiring correctly installed and maintained is acceptable, however, neglected aluminum wiring connections are a potential fire hazard. The Inspector recommends that you have the entire electrical system evaluated- and any necessary maintenance or corrections performed - by a qualified electrical contractor.**

Solid Aluminum wire?

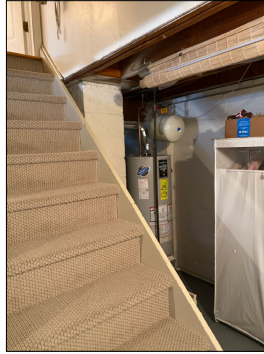
<b>Basement</b>		
Page 17 Item: 1	Basement Stairs	<ul style="list-style-type: none"> <li>Missing guardrails observed on the basement side of the stairs. This is a Safety Concern. Although guardrails may not have been required when the home was built, we recommend client consider installing guardrails as a safety enhancement.</li> </ul>

- Handrails missing or deficient on access stairs. According to modern building standards, the triangular opening at a guard at the open side of a stair formed by the riser, tread, and bottom rail of a guard must not allow a sphere 6 inches in diameter to pass through it. Recommend installation of new handrail by qualified contractor.
- **Missing guardrails observed on the basement side of the stairs. This is a Safety Concern. Although guardrails may not have been required when the home was built, we recommend client consider installing guardrails as a safety enhancement.**

Missing safety/handrail

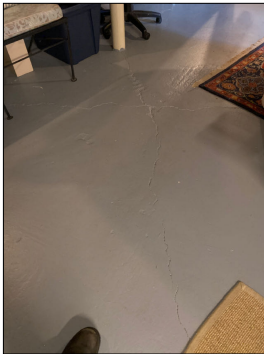
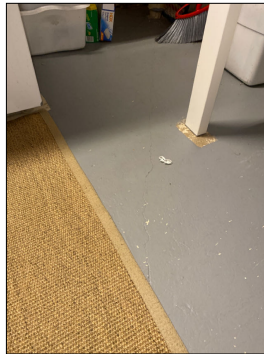
- A crack was observed at the basement floor in one or more place. The crack(s) was narrow and not displaced at the time of the inspection. No water ingress could be attributed to the crack. Monitor over time and if conditions change, consult with a qualified professional.
- Concrete Masonry Unit (CMU) foundation walls had vertical cracking visible in front RHS corner. These kinds of cracks are often associated with footing settlement. Crack(s) should be monitored over time and if cracking continues, the Inspector recommends that you contact a qualified professional to discuss options and costs for stabilization.

Crack

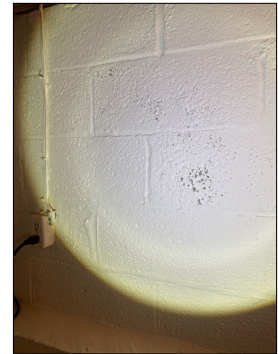
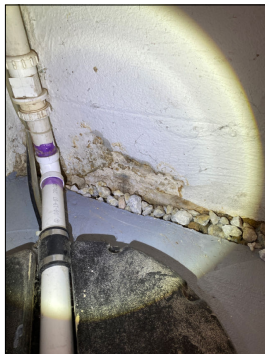
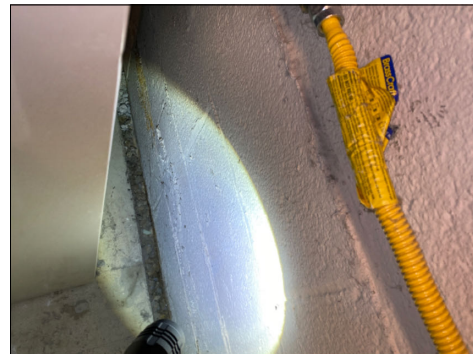
from moisture intrusion from the home exterior. This was seen mainly on the front of the home, consistent with the slope outdoors. This condition should be monitored to avoid continuing deterioration. The affected walls appeared to be structurally sound at the time of the inspection.

Water / efflorescence

Water staining / efflorescence

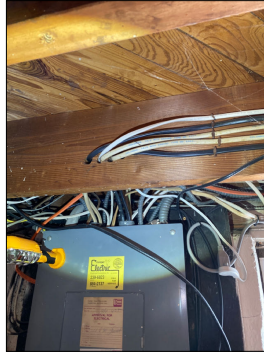
Improper drilling/notching

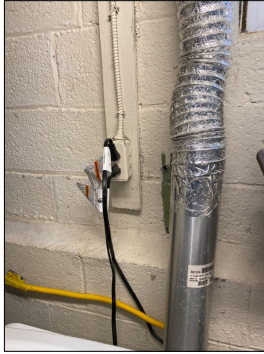
Page 20 Item: 9	Laundry Area	<ul style="list-style-type: none"> <li>No ground fault circuit interrupter (GFCI) protection of electrical receptacles was provided in the laundry area at the time of inspection. Although GFCI protection may not have been required at the time the home was built, generally accepted modern building practices require that electrical receptacles located within 6ft of a sink/water source be provided with GFCI protection in good working order to avoid potential electric shock or electrocution hazards. Recommend that the outlet be upgraded to GFCI by a qualified electrical contractor. This can be achieved relatively inexpensively by replacing the receptacle with a GFCI receptacle.</li> </ul>
-----------------	--------------	---

Non-GFCI

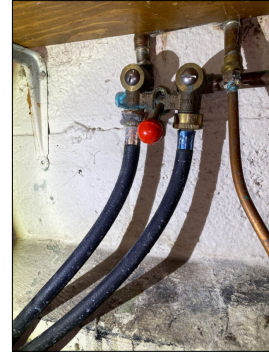
Plumbing leak

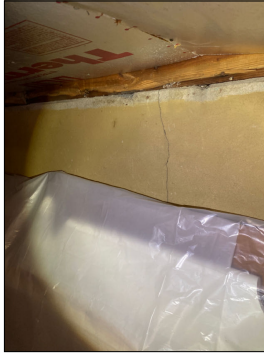
Crack

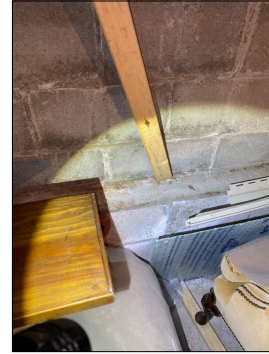
- Foundation walls exhibited minor efflorescence/staining that appeared to be from moisture intrusion from the home exterior. Moisture meter readings were normal at the time of the inspection. This condition should be monitored to avoid continuing deterioration. The affected walls appeared to be structurally sound at the time of the inspection.

Water staining / efflorescence

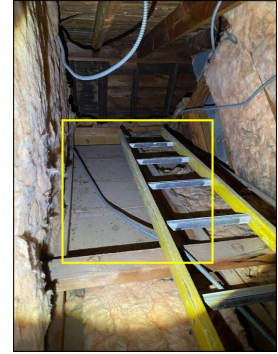
Missing insulation

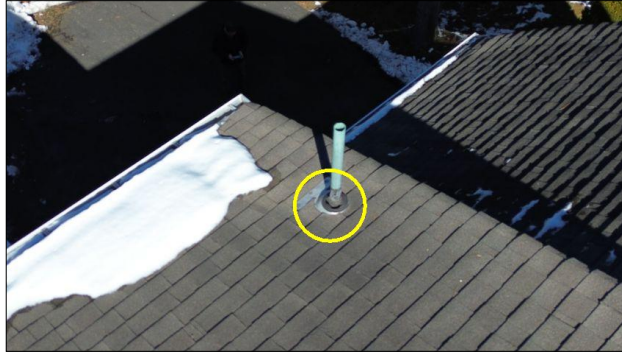
- The **vent boot** at a roof plumbing vent pipe **flashing** was cracked/damaged and may allow moisture intrusion of the roof assembly. If left unattended the condition can be expected to worsen which may lead to wood rot, mold and ultimately structural damage. The Inspector recommends replacement by a qualified roofing contractor.

Vent boot deterioration

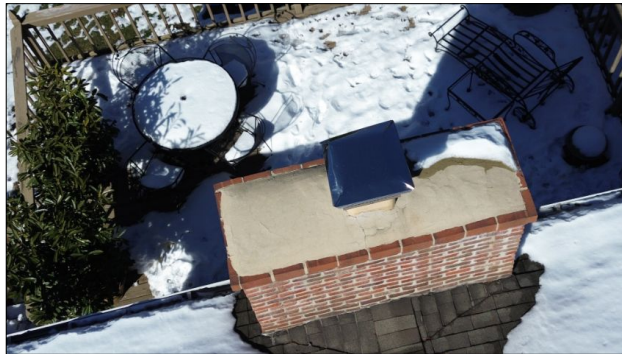
- Two masonry chimneys were noted.
- The chimneys had a mastic flashing. Mastic is susceptible to weather degradation and this should be viewed as a maintenance item to be checked and reapplied as necessary approximately every 10 years.
- Moderate cracking visible in the chimney cap should be filled with an appropriate sealant to prevent worsening damage caused by moisture in the cracks expanding as it freezes. All work should be performed by a qualified contractor.

Crown/cap

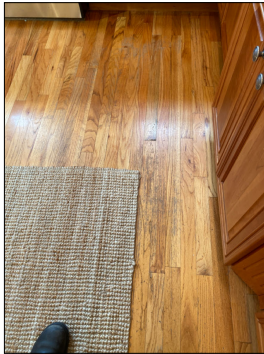
- Floor shows area(s) of localized damage. Suggest further evaluation and presentation of options by a qualified professional within the inspection contingency period.
- Sealant where the counter meets the wall was old and had sections of missing/damaged caulk which may allow damage from moisture intrusion of the wall assembly. The Inspector recommends correction by a qualified contractor.
- The cabinetry is older and in a condition commensurate with its age. At the time of the inspection, cabinetry was functional.

Local damage

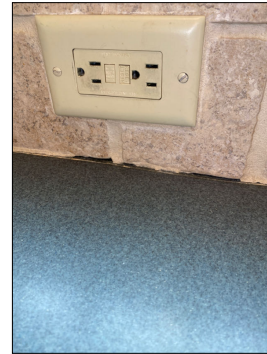
Caulking failure

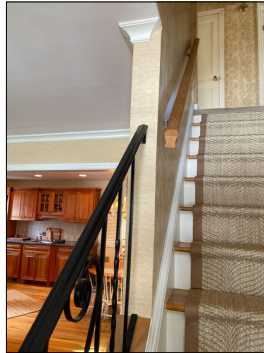
- Handrails deficient on stairs. Although it may have complied with standards that were generally accepted at the time of its original construction, the handrail assembly did not comply with generally-accepted current safety standards. A continuous handrail should be present for safety - that is, a hand can slide along the rail without interruption from above the top riser to above the bottom riser. Recommend improvement of handrail by a qualified contractor.

Deficient handrail

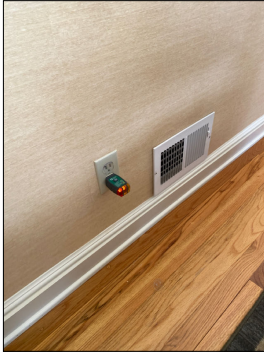
Miswired receptacle. Dining

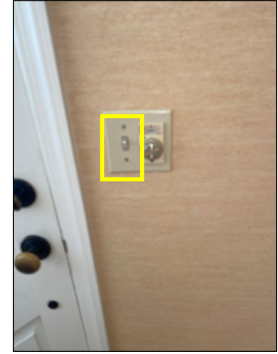
Inoperative / unknown fixture control

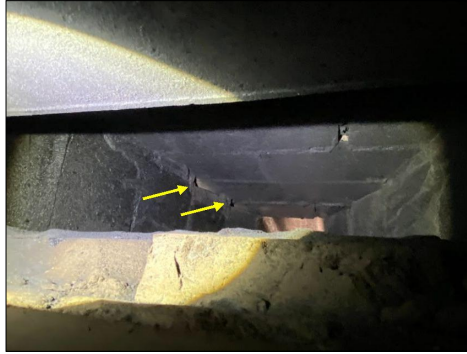
Living Areas		
Page 29 Item: 2	Fireplace	<ul style="list-style-type: none"> <li>• Gaps were visible at the edges of the smoke chamber (space above the damper and before the flue) the of the fireplace. This condition may allow the toxic, corrosive products of combustion to damage the chimney structure or enter the living space which is a safety issue The Inspector recommends review and repair by a qualified contractor.</li> </ul>
Bathroom 1		
Page 31 Item: 3	Windows and Doors	<ul style="list-style-type: none"> <li>• The bottom sash of at least one window in this room would not stay in place when the window was raised. This prevents normal functioning of the window and could represent a safety issue if the sash falls on someone while operating the window. The Inspector recommends repair by a qualified contractor.</li> </ul>
Attached Garage		
Page 34 Item: 2	Access Door	<ul style="list-style-type: none"> <li>• The door between the garage and the home living space did not have operable self-closing hinges as is required by modern generally-accepted current safety standards. This presents a potential safety hazard. Recommend engaging a qualified professional to upgrade as necessary.</li> </ul>

Mortar Gaps

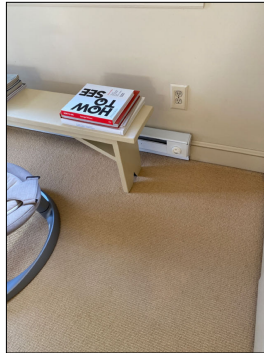
Page 30 Item: 3	AC and Heat	<ul style="list-style-type: none"> <li>One or more electric baseboard heater in the family room failed to provide heat upon demand. The Inspector recommends this is reviewed by an electrician before the end of your due diligence period.</li> </ul>
-----------------	-------------	---

- One or more electric baseboard heater in the family room failed to provide heat upon demand. The Inspector recommends this is reviewed by an electrician before the end of your due diligence period.

Unresponsive baseboard

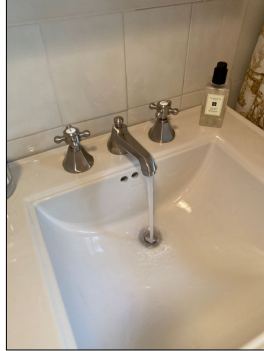
- The stopper at the sink was missing or not operating correctly. Recommend repair by a qualified professional.

Inoperable stopper

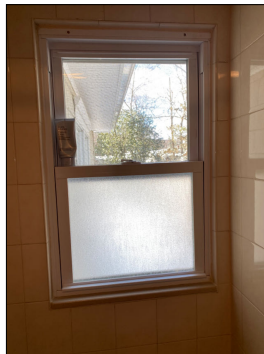
- Modern building safety standards typically require that tempered glazing is required in any windows at bathtubs and showers where the glazing is less than 5ft above the standing surface. This is for safety reasons in the event of a slip and fall. We recommend you consult with a qualified professional to ensure this window is compliant.
- The bottom sash of at least one window in this room would not stay in place when the window was raised. This prevents normal functioning of the window and could represent a safety issue if the sash falls on someone while operating the window. The Inspector recommends repair by a qualified contractor.

Defective

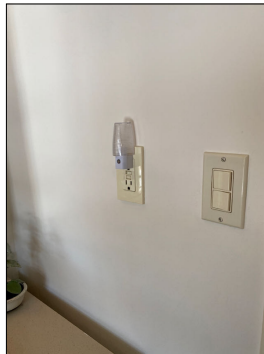
GFCI faulty

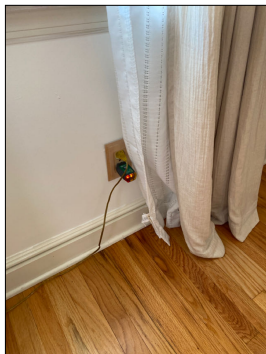
Incorrectly wired receptacle, #1

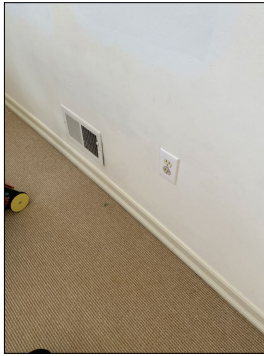
Loose, #3

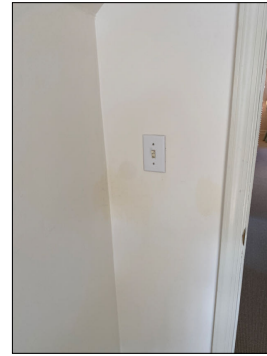
- The inspector was unable to determine what device is controlled by a switch in Bedroom # 3. (see picture)
- Bedroom 3 . A closet light in this bedroom had an exposed bulb, which could be a fire hazard. Recommend adding a guard or changing bulb to LED. Any necessary repairs should be performed by a qualified electrical contractor.

Control could not be determined, #3

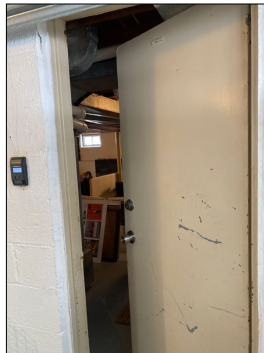
- The door between the garage and the home living space did not have operable self-closing hinges as is required by modern generally-accepted current safety standards. This presents a potential safety hazard. Recommend engaging a qualified professional to upgrade as necessary.

No self-closing hinges

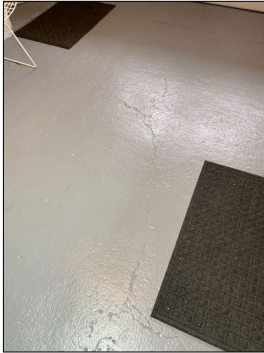
Floor damage

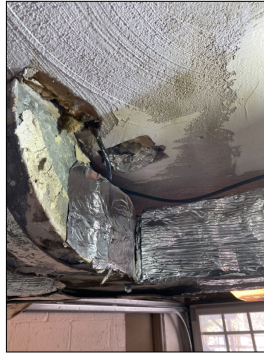
Page 35 Item: 3	Walls/ceilings/floor	<ul style="list-style-type: none"> <li>• The wall/ceiling separating the garage from the home living space did not meet generally-accepted current standards for firewalls. Firewalls are designed to resist the spread of a garage fire for a certain length of time in order to give the home's occupants adequate time to escape. This requires a continuous sheetrock covering of 1/2" on walls next to habitable spaces and 5/8" on ceilings beneath habitable spaces. The Inspector recommends correction by a qualified contractor.</li> </ul>
Page 35 Item: 5	Ducts	<ul style="list-style-type: none"> <li>• Heat ducts are wrapped with materials consistent with that containing asbestos which is a know cancer causing material. If in good condition and left undisturbed this material causes no need for alarm. It is noted that there is at least one area that is exposed and/or in disrepair. Proper handling and abatement by Qualified contractors is recommended if repairs or upgrades are performed. We recommend you have the insulation reviewed by a qualified contractor before the end of your due diligence period to fully</li> </ul>

- Floor is cracked in one or more locations. Suggest further evaluation by a licensed contractor within the inspection contingency period.
- The wall/ceiling separating the garage from the home living space did not meet generally-accepted current standards for firewalls. Firewalls are designed to resist the spread of a garage fire for a certain length of time in order to give the home's occupants adequate time to escape. This requires a continuous sheetrock covering of 1/2" on walls next to habitable spaces and 5/8" on ceilings beneath habitable spaces. The Inspector recommends correction by a qualified contractor.

Sheetrock not continuous
