Home Inspection Report

999 Any Street, AnyTown NJ 07000

Prepared For: John Sample
Inspection Date: 1/1/2024

Inspector: Martin Slon BSEng(Civil)
Home Inspector License # GI2266
118 Elm Street, Montclair NJ 07042

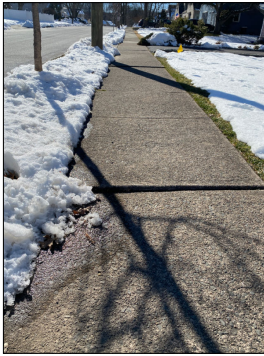
- The sidewalk has potential tripping hazard(s). This is where an abrupt change of 1" or more in the height of the surface is seen, or local deterioration and discontinuities are present. Recommend repair by a qualified professional.
- It was noted the surface of the driveway has areas that are settled and areas of generalized cracks . Recommend to have these areas repaired by a qualified professional to prevent further deterioration.

Trip Hazard

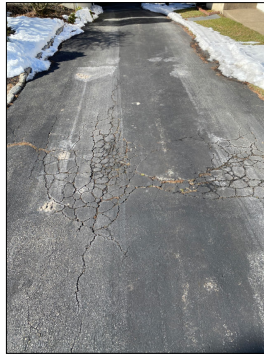
Local deterioration

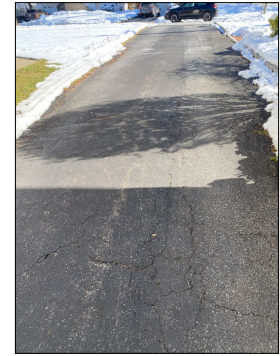
Local deterioration

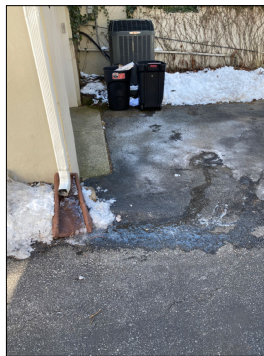
- One or more downspouts/leaders drained too close to the foundation. Excessively high moisture levels in soil supporting the foundation can effect its ability to support the weight of the structure above and can introduce water into the basement. Runoff water diverters should slope away from the home a minimum of ¼-inch per foot for a distance of at least six feet from the foundation. The Inspector recommends that these be corrected to improve drainage near the foundation.

Discharge too close to foundation

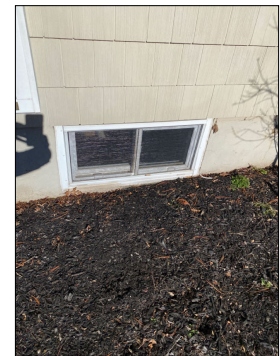
- The top of the foundation wall had inadequate clearance from grade. The top of the foundation wall should ideally be a minimum of six inches above soil. Inadequate clearance may result in moisture intrusion of the structure. Excessively high moisture levels can result in damage to the home structure or materials from decay or deterioration and may result in conditions which encourages rot and the growth of microbes such as mold fungi. The Inspector recommends re-grading around the home perimeter to provide increased clearance from grade.

Poor foundation clearance

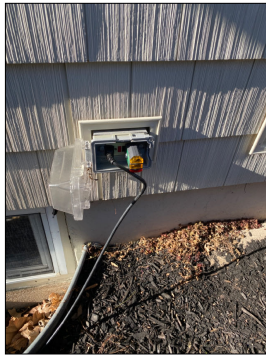
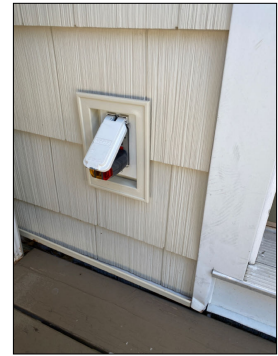
Incorrectly wired

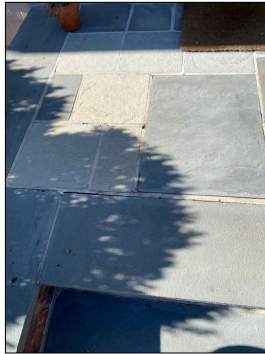
- Localized cracks/deterioration are noted at the front landing. These should be repaired by a qualified professional using appropriate material to avoid continued damage from freezing moisture.
- The door and/or it's seal is damaged at the rear deck door. This may have been caused by a dog. It

Cracking

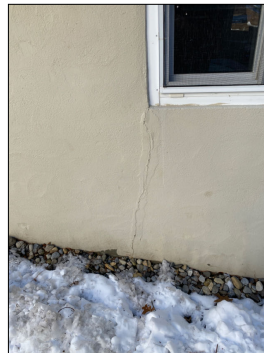
- Vinyl siding/shingles is/are the predominant type.
- Vertical cracks observed at foundation. No deflection of wall was visible at time of inspection. All buildings settle with minor wall and foundation cracking visible likely at some point. Recommend monitoring cracks for any changes, and having a qualified professional evaluate further should the cracks enlarge beyond their current size.

Cracking

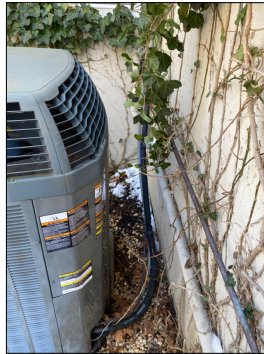
Vegetation

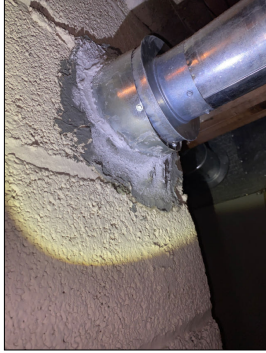
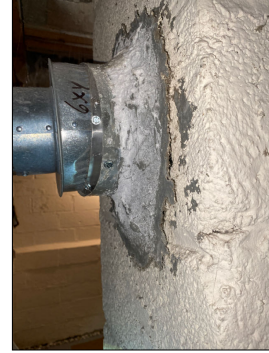
- The exhaust vent joint at the chimney shows signs of deterioration. This is a potentially hazardous condition if left unattended and that may allow toxic products of combustion (such as carbon monoxide) to enter the living space. The Inspector recommends repair by a qualified professional as part of your first annual boiler maintenance.

Junction deterioration

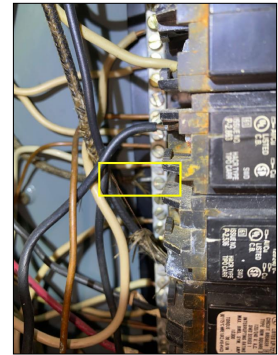
- Branch wiring visible inside the service panel MAY contain solid aluminum wiring which was commonly used in the 60's and 70's. Aluminum wiring correctly installed and maintained is acceptable, however, neglected aluminum wiring connections are a potential fire hazard. The Inspector recommends that you have the entire electrical system evaluated- and any necessary maintenance or corrections performed - by a qualified electrical contractor.

Solid Aluminum wire?

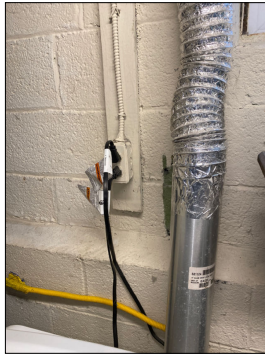
Non-GFCI

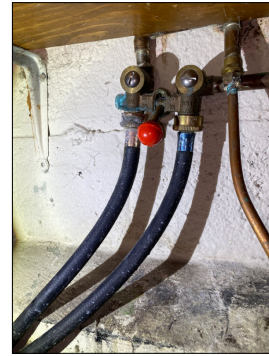
Page 19 Item: 9	Laundry Area	<ul style="list-style-type: none"> The sink plumbing was leaking at the time of inspection. Engage a qualified professional to repair/replace as necessary.
-----------------	--------------	--

Plumbing leak

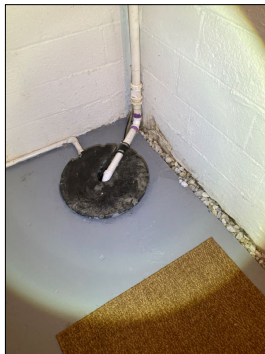
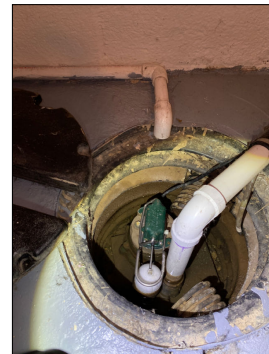
- The pit had water in the bottom and french drain(s) were observed.
- The sump pit is covered, but installed piping prevents a proper fit. This represents a potential safety hazard. Recommend correcting the cover.

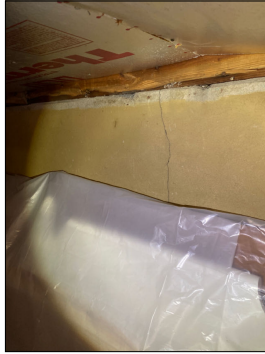
Crack

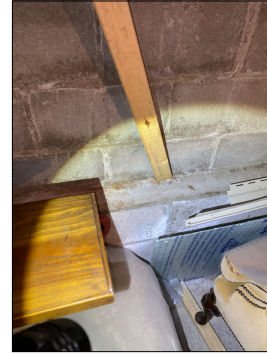
- Foundation walls exhibited minor efflorescence/staining that appeared to be from moisture intrusion from the home exterior. Moisture meter readings were normal at the time of the inspection. This condition should be monitored to avoid continuing deterioration. The affected walls appeared to be structurally sound at the time of the inspection.

Water staining / efflorescence

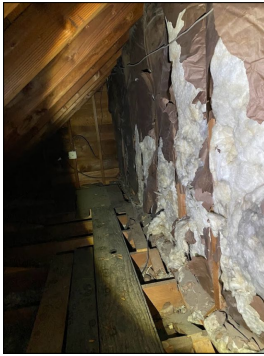
Incorrectly installed insulation

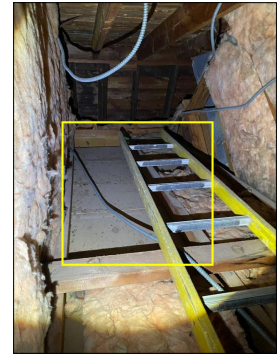
Missing insulation

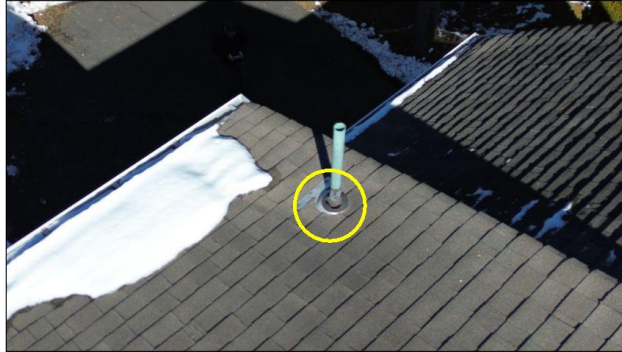
Roof		
Page 24 Item: 2	Flashing	<ul style="list-style-type: none"> The vent boot at a roof plumbing vent pipe flashing was cracked/damaged and may allow moisture intrusion into the roof assembly. If left unattended the condition can be expected to worsen which may lead to wood rot, mold and ultimately structural damage. The Inspector recommends replacement by a qualified roofing contractor.
Living Areas		
Page 28 Item: 2	Fireplace	<ul style="list-style-type: none"> Gaps were visible at the edges of the smoke chamber (space above the damper and before the flue) the of the fireplace. This condition may allow the toxic, corrosive products of combustion to damage the chimney structure or enter the living space which is a safety issue The Inspector recommends review and repair by a qualified contractor.
Bathroom 1		
Page 30 Item: 3	Windows and Doors	<ul style="list-style-type: none"> The bottom sash of at least one window in this room would not stay in place when the window was raised. This prevents normal functioning of the window and could represent a safety issue if the sash falls on someone while operating the window. The Inspector recommends repair by a qualified contractor.

- The **vent boot** at a roof plumbing vent pipe **flashing** was cracked/damaged and may allow moisture intrusion into the roof assembly. If left unattended the condition can be expected to worsen which may lead to wood rot, mold and ultimately structural damage. The Inspector recommends replacement by a qualified roofing contractor.

Vent boot deterioration

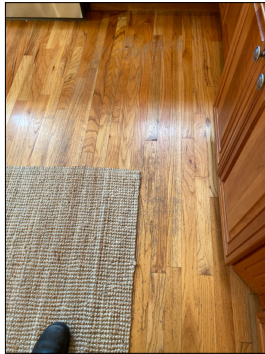
- Floor shows area(s) of localized damage. Suggest further evaluation and presentation of options by a qualified professional within the inspection contingency period.
- Sealant where the counter meets the wall was old and had sections of missing/damaged caulk which may allow damage from moisture intrusion of the wall assembly. The Inspector recommends correction by a qualified contractor.
- The cabinetry is older and in a condition commensurate with its age. At the time of the inspection, cabinetry was functional.

Local damage

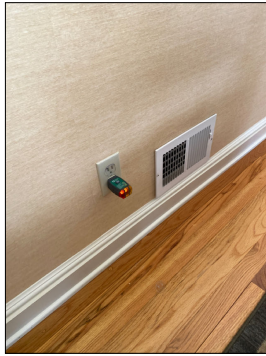
Miswired receptacle. Dining

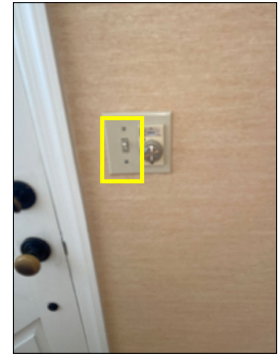
Inoperative / unknown fixture control

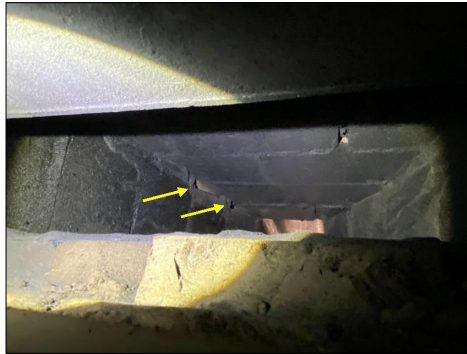
Mortar Gaps

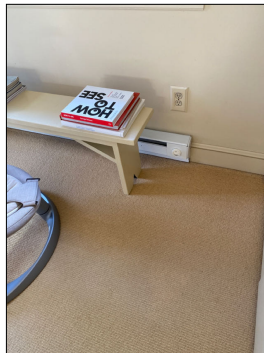
Living Areas		
Page 29 Item: 3	AC and Heat	<ul style="list-style-type: none"> One or more electric baseboard heaters in the family room failed to provide heat upon demand. The Inspector recommends this is reviewed by an electrician before the end of your due diligence period.
Bathroom 2		
Page 31 Item: 2	Electrical	<ul style="list-style-type: none"> The lighting for this bathroom is on the same circuit and when the GFCI trips, the room goes dark. This is not safe and is likely not code compliant. Check with a qualified professional if this is code compliant, and correct as necessary. The ground fault circuit interrupter (GFCI) electrical receptacle could not be tripped using the test button. The Inspector recommends receptacle repair or replacement as needed by a qualified electrical contractor.

- One or more electric baseboard heaters in the family room failed to provide heat upon demand. The Inspector recommends this is reviewed by an electrician before the end of your due diligence period.

Unresponsive baseboard

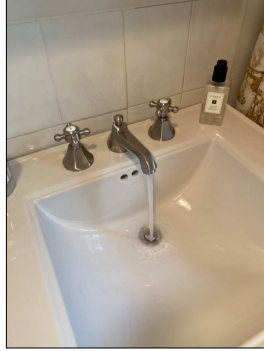
- The stopper at the sink was missing or not operating correctly. Recommend repair by a qualified professional.

Inoperable stopper

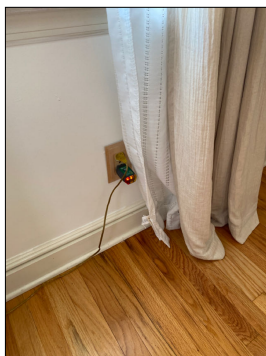
Incorrectly wired receptacle, #1

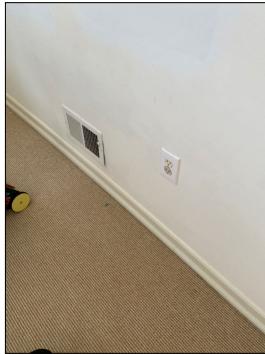
Loose, #3

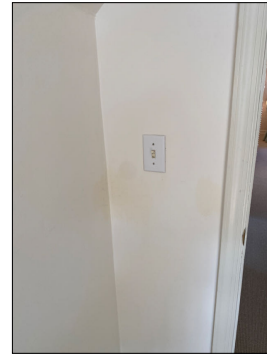
Control could not be determined, #3

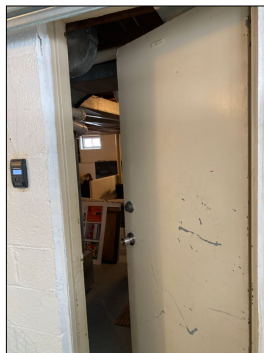
Attached Garage		
Page 33 Item: 2	Access Door	<ul style="list-style-type: none"> The door between the garage and the home living space did not have operable self-closing hinges as is required by modern generally-accepted current safety standards. This presents a potential safety hazard. Recommend engaging a qualified professional to upgrade as necessary.
Page 34 Item: 3	Walls/ceilings/floor	<ul style="list-style-type: none"> The wall/ceiling separating the garage from the home living space did not meet generally-accepted current standards for firewalls. Firewalls are designed to resist the spread of a garage fire for a certain length of time in order to give the home's occupants adequate time to escape. This requires a continuous sheetrock covering of 1/2" on walls next to habitable spaces and 5/8" on ceilings beneath habitable spaces. The Inspector recommends correction by a qualified contractor.

- The door between the garage and the home living space did not have operable self-closing hinges as is required by modern generally-accepted current safety standards. This presents a potential safety hazard. Recommend engaging a qualified professional to upgrade as necessary.

No self-closing hinges

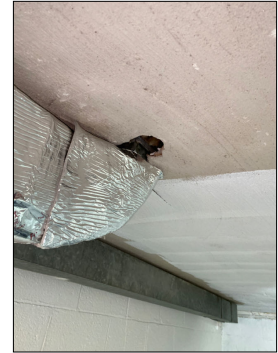
- Floor is cracked in one or more locations. Suggest further evaluation by a licensed contractor within the inspection contingency period.
- The wall/ceiling separating the garage from the home living space did not meet generally-accepted current standards for firewalls. Firewalls are designed to resist the spread of a garage fire for a certain length of time in order to give the home's occupants adequate time to escape. This requires a continuous sheetrock covering of 1/2" on walls next to habitable spaces and 5/8" on ceilings beneath habitable spaces. The Inspector recommends correction by a qualified contractor.

Sheetrock not continuous
