# Brookfield Home Inspections

## Home Inspection Report

999 Any Street, AnyTown NJ 07000

Prepared For: John Sample  
Inspection Date: 1/1/2024

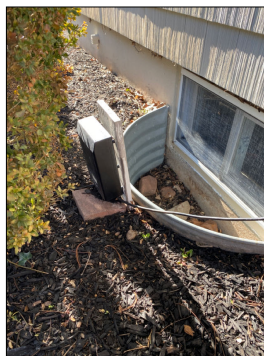
Low voltage light board

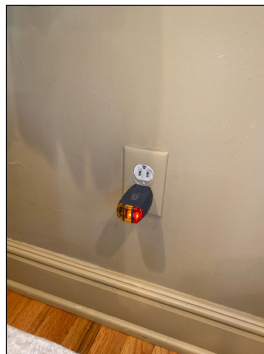
Incorrectly wired receptacle, #2

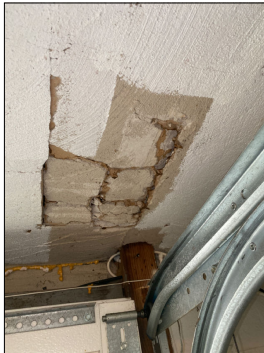
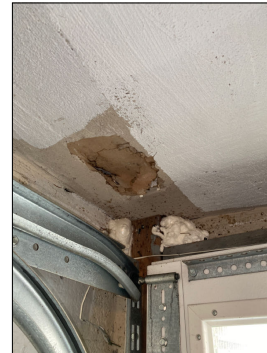
Page 35 Item: 3	Walls/ceilings/floor	<ul style="list-style-type: none"> <li>• The wall/ceiling separating the garage from the home living space did not meet generally-accepted current standards for firewalls. Firewalls are designed to resist the spread of a garage fire for a certain length of time in order to give the home's occupants adequate time to escape. This requires a continuous sheetrock covering of 1/2" on walls next to habitable spaces and 5/8" on ceilings beneath habitable spaces. The Inspector recommends correction by a qualified contractor.</li> </ul>
Page 35 Item: 5	Ducts	<ul style="list-style-type: none"> <li>• Heat ducts are wrapped with materials consistent with that containing asbestos which is a know cancer causing material. If in good condition and left undisturbed this material causes no need for alarm. It is noted that there is at least one area that is exposed and/or in disrepair. Proper handling and abatement by Qualified contractors is recommended if repairs or upgrades are performed. We recommend you have the insulation reviewed by a qualified contractor before the end of your due diligence period to fully</li> </ul>

Sheetrock not continuous
