# Brookfield Home Inspections

## Home Inspection Report

999 Any Street, AnyTown NJ 07000

Prepared For: John Sample  
Inspection Date: 1/1/2024

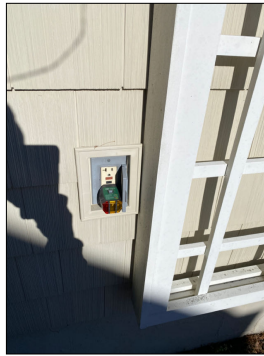
Incorrectly wired

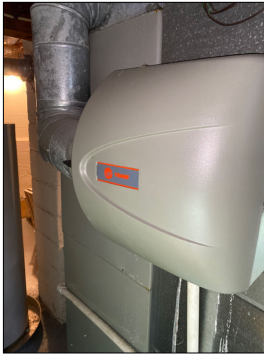
- The presence of a whole house humidifier is noted. Inspection of a humidifier is beyond the scope of a Home Inspection. As a courtesy it is noted that these require regular maintenance every 2-3 months and will depend on humidifier usage, water hardness etc. It is further noted that there is evidence of water leakage at the unit. We recommend having this evaluated by a qualified HVAC contractor, who can also provide specific repair and maintenance advice.

Humidifier

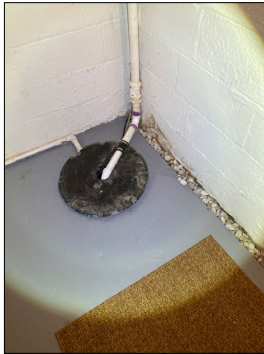
- Sump discharges through exterior wall. Typically, water must be discharged at least 20 feet from the building. Recommend review of current plumbing configuration to ensure operable drainage and conformance with local building regulations. Sump pump drainage/discharge is beyond the scope of a home inspection and is disclaimed.

- The pit had water in the bottom and french drain(s) were observed.
- The sump pit is covered, but installed piping prevents a proper fit. This represents a potential safety hazard. Recommend correcting the cover.

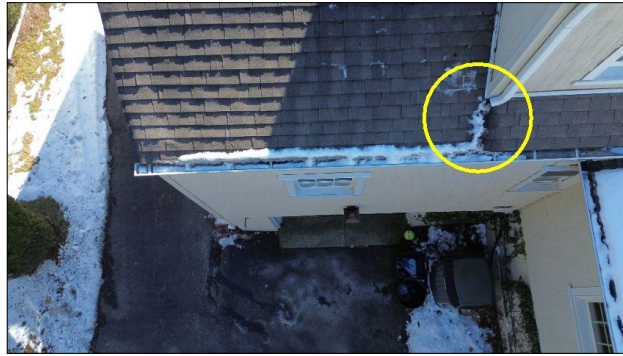
Discharge point

- Downspouts missing or too short between upper and lower roof. This can lead to staining and accelerated deterioration of the drainage path below the upper gutter discharge. Recommend installation of extenders by qualified professional.

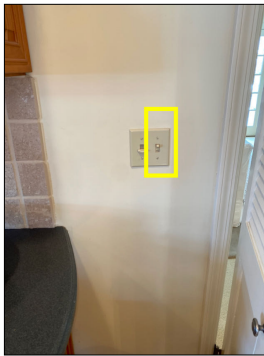
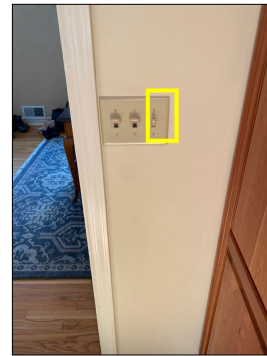
- The inspector was unable to determine what device is controlled by the switches pictured. Confirm with seller or have the circuit reviewed by a qualified electrician.

Unknown control

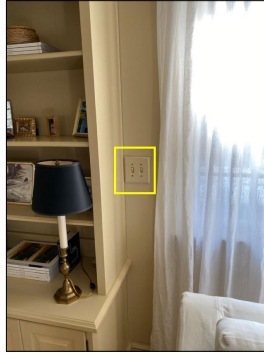
Unknown control

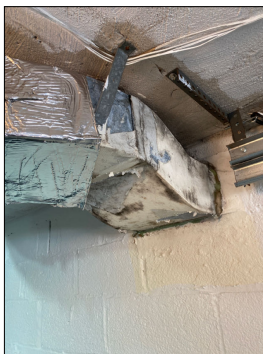
Asbestos
