Home Inspection Report

999 Any Street, AnyTown NJ 07000

Prepared For: John Sample
Inspection Date: 1/1/2024

Inspector: Martin Slon BSEng(Civil)
Home Inspector License # GI2266
118 Elm Street, Montclair NJ 07042

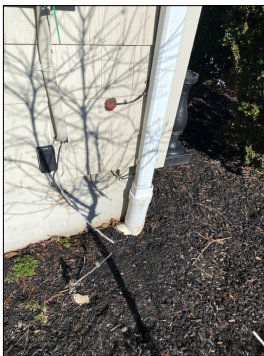
Underground drainage

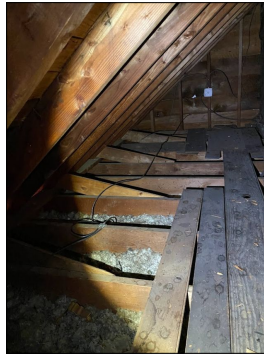
Insufficient insulation

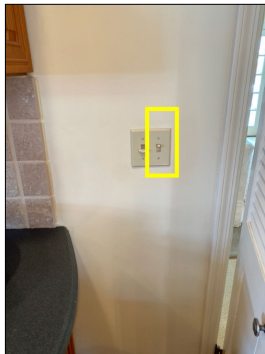
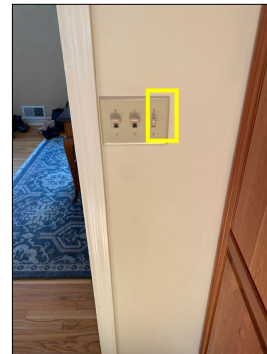
- The inspector was unable to determine what device is controlled by the switches pictured. Confirm with seller or have the circuit reviewed by a qualified electrician.

Unknown control

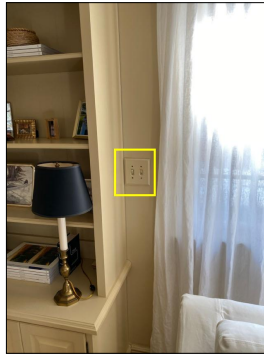
Unknown control

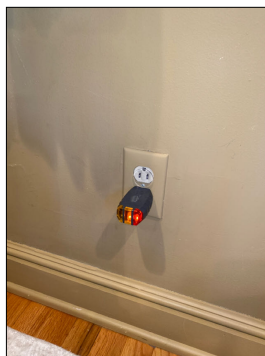
Incorrectly wired receptacle, #2

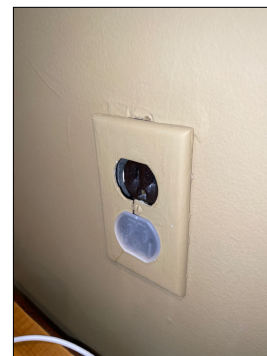
Non-flush cover plate, #2

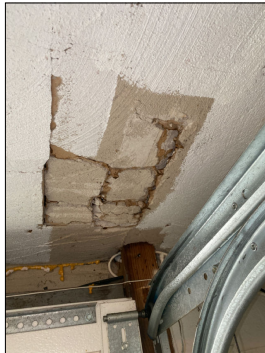
Sheetrock not continuous

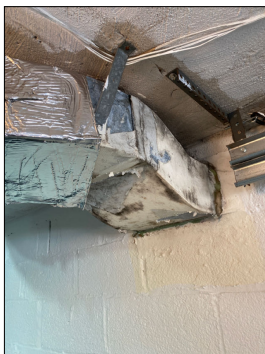
Page 34 Item: 5	Ducts	<ul style="list-style-type: none"> Heat ducts are wrapped with materials consistent with that containing asbestos which is a know cancer causing material. If in good condition and left undisturbed this material causes no need for alarm. It is noted that there is at least one area that is exposed and/or in disrepair. Proper handling and abatement by Qualified contractors is recommended if repairs or upgrades are performed. We recommend you have the insulation reviewed by a qualified contractor before the end of your due diligence period to fully understand your options and the associated costs.

Asbestos
